CLOSING THE GAP BETWEEN
DESIGN

AS-BUILT
PERFORMANCE

Evidence Review Report

March 2014

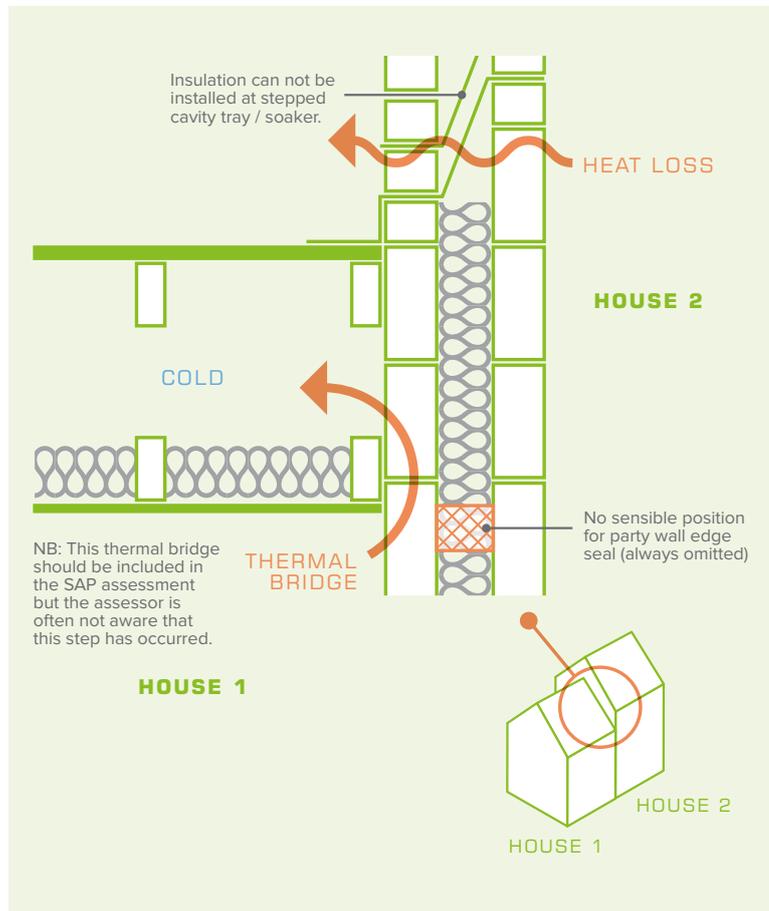
Site observations and SAP Audits on all developments identified differences between the designed junctions and those built. The illustration provides a common example where a stepped terrace of standard house types joined together has contributed to the creation of complex roof areas, leading to difficulties in installing party wall edge seals and the full extent of insulation. This presents challenges both for the design team to provide sufficiently clear details and the construction team to replicate these robustly and efficiently on site.

Examples of buildability issues were observed on several of the sites visited due to the inclusion of complex features in the design. On three sites, construction of the bays and dormers did not match the detailing assumed in the SAP assessments for linear thermal bridging - in one case this example was found to cause a deviation of just under 1% to the Dwelling Emission Rate (DER). This could represent a compliance risk particularly given that dwellings are often designed to only just comply with the Target Emission Rate, or when compounded by other deviations to the DER.

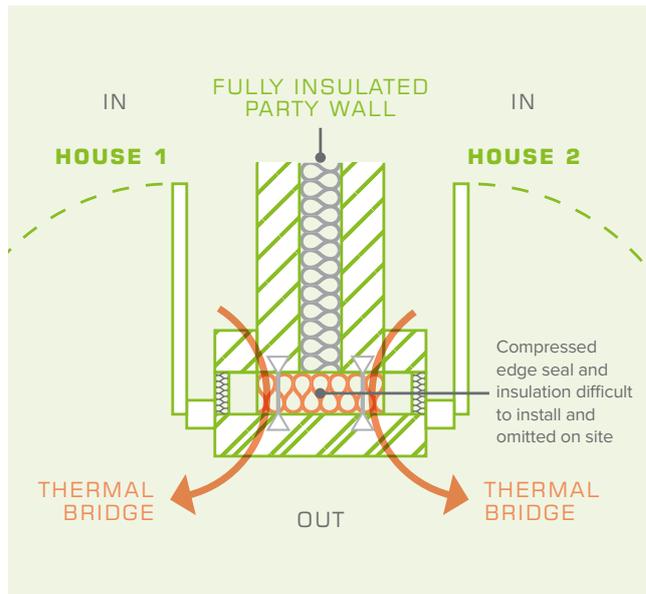
Instances of inadequate understanding or consideration of design implications were identified on all sites. The illustration below is an example in which the design assumed that the compressed edge seal, insulation and wall ties could all be installed practically despite the lack of space. On site, it was found that the insulation and edge seal had been omitted, as structural considerations had to take priority. This might in part be due to standard house types being drawn in isolation without consideration of how they combine on site.

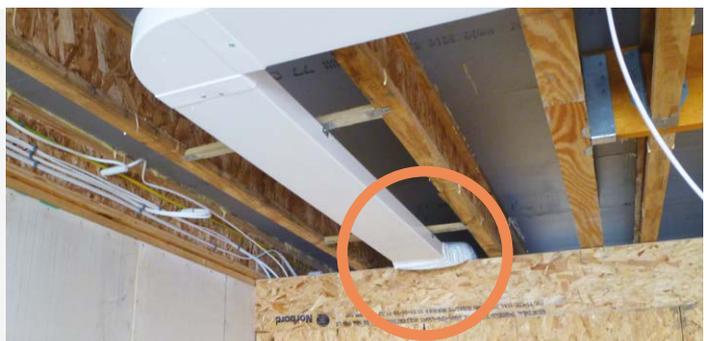
Improvised construction – a short piece of flexible ductwork used to negotiate a difference in levels. Due to a lack of coordinated design information, the rigid ductwork runs below the top of the internal partition.⁷

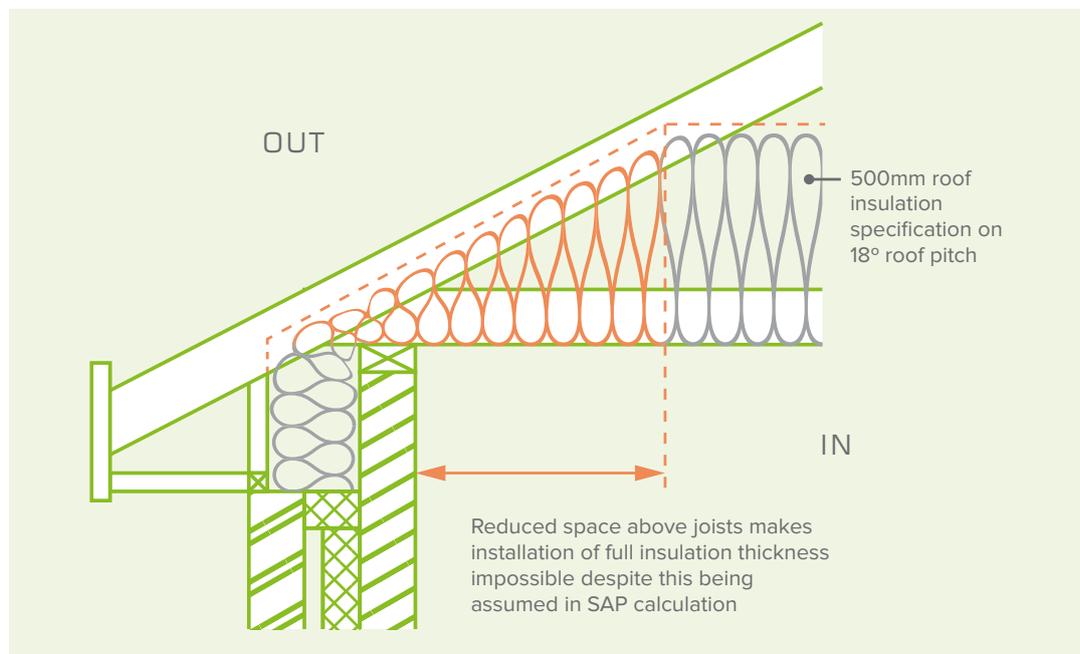
An instance where such knowledge and skills should be applied is illustrated here.

It would clearly be unfair to place sole responsibility for buildability issues such as this roof insulation detail on the SAP assessor. However, the manner in which they decide to calculate the U-value is important. When calculating the roof U-value it would be incorrect to simply assume that the same thickness of insulation could be installed over the entire roof area, because of the clear impossibility of fitting this into the eaves when the roof pitch is so low.

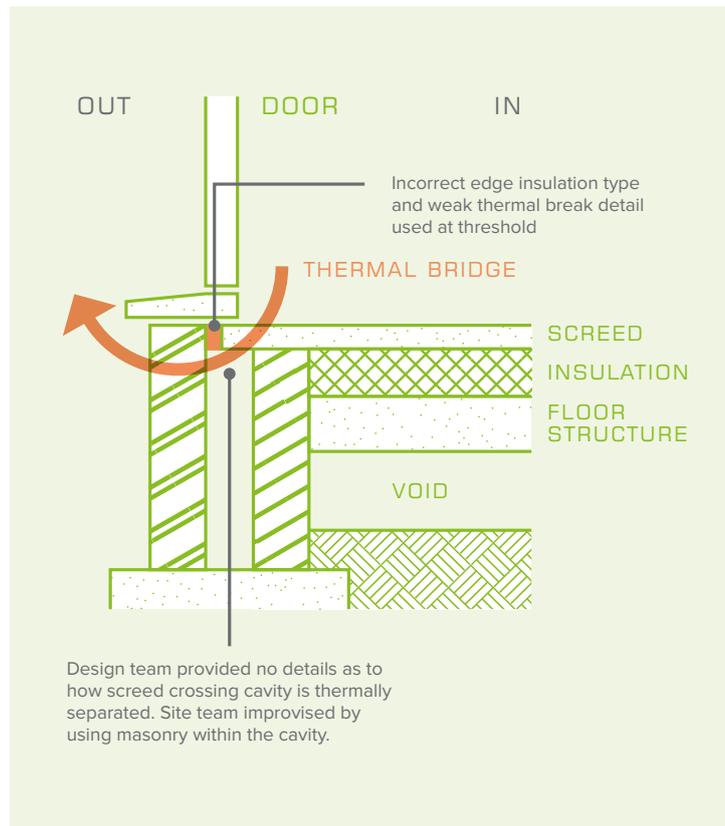
The illustration provides a good example of where the detail as constructed deviates from the design.

The SAP Audits indicate that all sites show a difference in the actual thermal bridge values. Issues such as the distance of insulation boards from cavity wall blockwork and the density of foundation blockwork also impact on the SAP calculations.

'Floating' insulation boards were found on many of the sites included in the Housebuilding Process Review - i.e. boards were not secured to the blockwork within partially filled cavity walls, in some cases leaving gaps of as much as 10mm. A study included in the Literature Review found that poor insulation board placement and fit increased U-values by over 350% in the case of rigid board partial fill, based on a nominal U-value of around $0.2\text{W/m}^2\text{K}$.¹

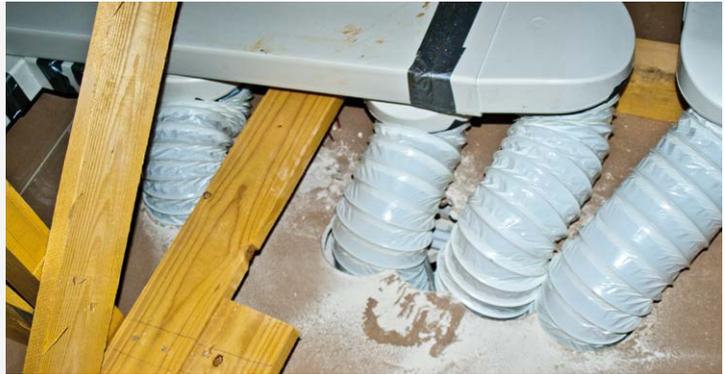
Unsupported flexible ductwork used to connect with MVHR fan unit below ceiling. Ductwork routing has been 'improvised' on site.¹

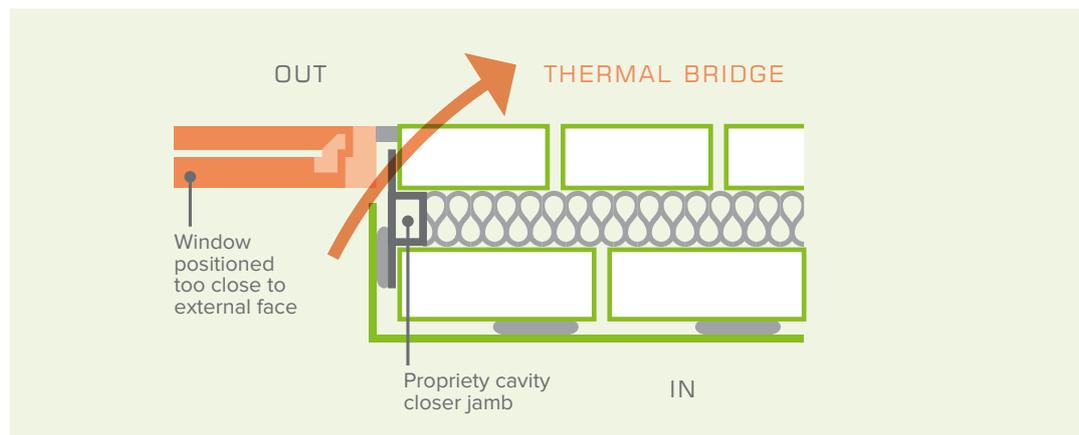
Windows were pulled forward from their design positions on all but one of the sites visited under the Housebuilding Process Review. This meant that the overlap with the cavity closer was well below the minimum requirements, with gaps sealed with mastic or foam fill which in several cases was interrupted by metal fixing straps. These issues would impact on the air barrier and insulation continuity and would increase thermal bridging around the windows, particularly in flats where glazing accounts for a higher proportion of the facade. Doors were also frequently out of position.

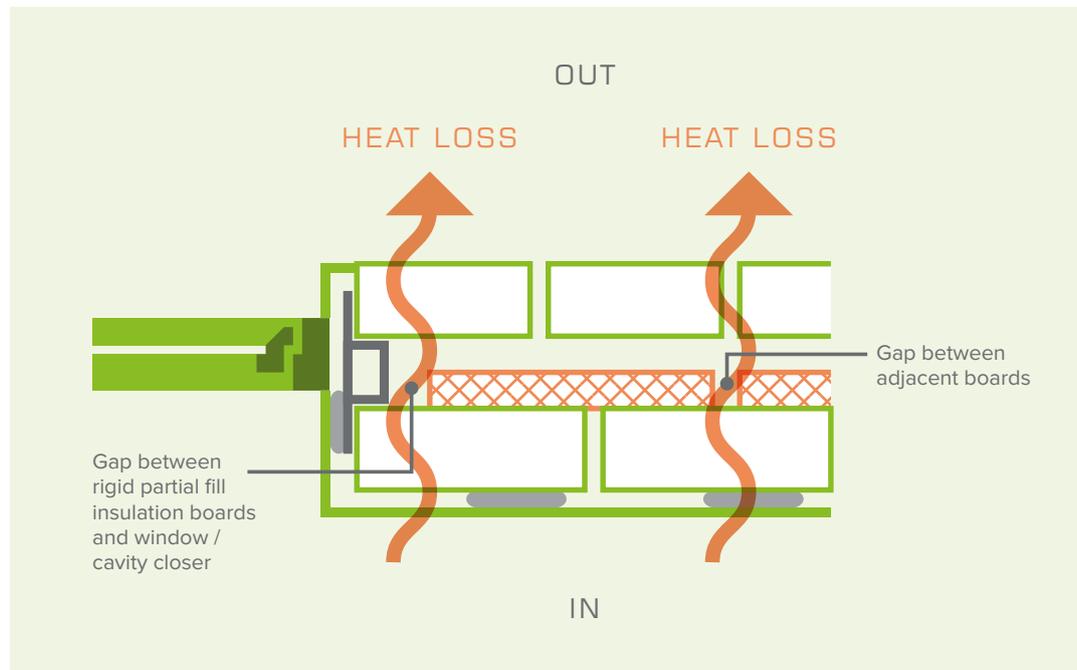
Many examples were observed on site of cavity insulation board stopping short of cavity closers at openings and of gaps between boards leading to increased heat loss, as shown in this illustration.
